NOTICE OF VIOLATION

RE: Central Hudson Gas & Electric Corporation Training Center

Construction Stormwater Inspection Report for SPDES General Permit GP-0-20-001

NYSDEC Inspection Photo Log Central Hudson Training Center Town of Ulster, Ulster County SPDES Permit ID: NYR11G073 Inspection Date: 8/3/21

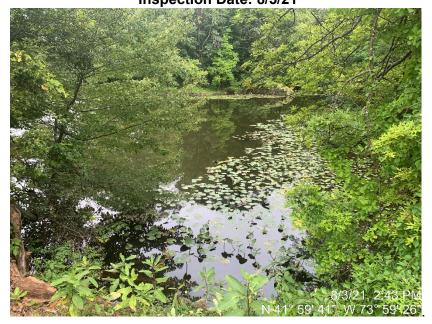
At the time of the inspection, the water quality in the wetland was indicative of pollution from discharges from stormwater runoff related to construction activities. This is a violation of Article 17 of ECL. Please be advised that violations of the ECL are subject to penalties of up to \$37,500 per day per violation.

Photo 1: Turbidity in onsite wetland

All necessary erosion and sediment controls must be installed and implemented for the duration of the project to prevent any future violations and contraventions of New York State Water Quality Standards. We anticipate your compliance, which we will take into account before making a final determination on enforcement. If you have questions regarding this inspection, please contact me at (845) 255-3760 or douglas.upright@dec.ny.gov.

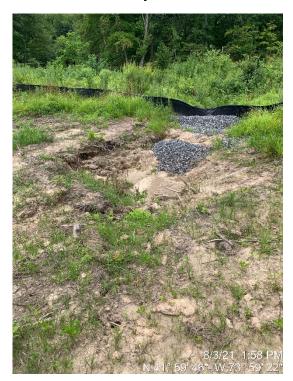
Photo 2: Silt fence in need of maintance
